Appendix A – Natural Heritage

Re: Existing Conditions, Impact Assessment and Mitigation Report Killarney Municipal Wharf Expansion and Redesign Killarney, Ontario

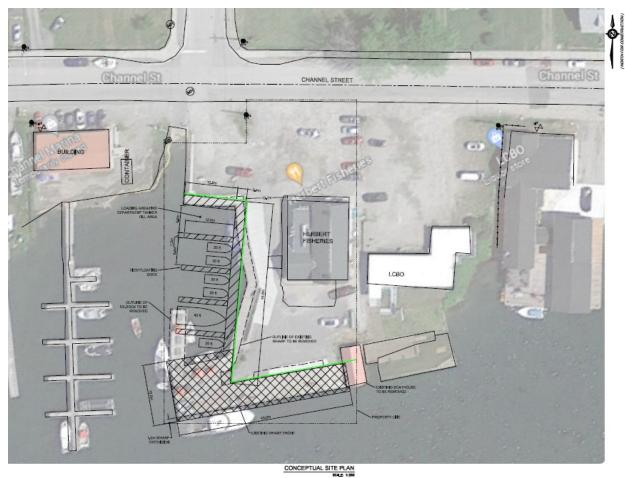
Figure 3: General Layout of Proposed Works

The site is located on the shoreline of Lake Huron (Killarney) at the existing Killarney Municipal Wharf on the north shore of Georgian Bay on Lake Huron (Figures 1 and 2). A general layout of the existing marina and proposed work is provided on Figure 3.

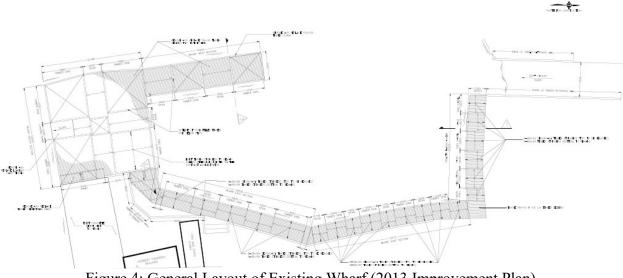
Figure 4: General Layout of Existing Wharf (2013 Improvement Plan)

The existing wharf extends about 60m to the south from the north shore of Lake Huron and extends along the shoreline (east to west) for about 25m (Figure 4). The existing wharf contain north, east, south and west sections. The north section (timber deck on timber cribs) abuts the north shore of Lake Huron for about 12.7m and is about 2.5m wide. The east section (timber deck on timber cribs) extends off the east end of the north section in two sections, a 19.5m long north half and an 18.5m long south half, with a bend in between the two sections. The south section (timber deck on timber cribs) is a large section which extends about 12.6m to the south and about 43m in an east to west direction. A 43m long concrete pad (supported on timber cribs) extends to the east of this area. An existing boat house is located at the east end of this concrete pad. The west section (timber deck on timber cribs) extends off the north with a width of about 3.6m.

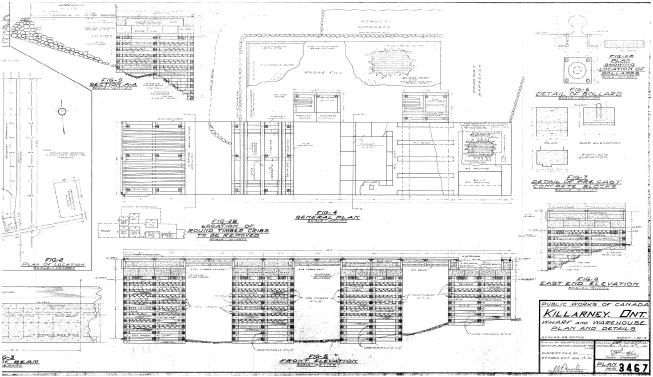
Figure 5: 1951 Drawings

Original drawings (1951) were provided for the wharf which generally illustrate the existing crib structure (Figure 5).

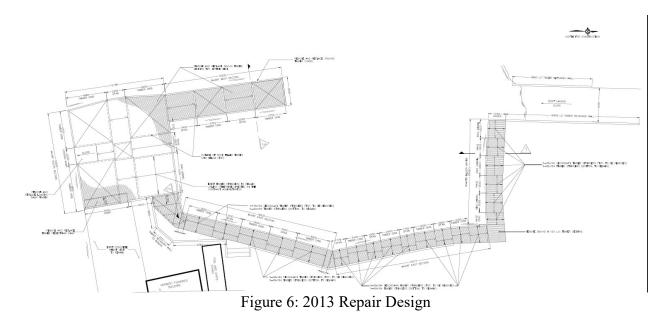
Repairs were completed to the existing wharf based on the 2013 drawings provided below (Figure 6). The repairs were mainly to existing timber decking and associated timber stringers. One crib at the north end of the west section was replaced. The measurements provided generally agree with those noted during the site visit.

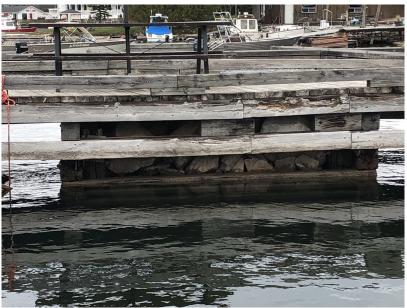
Figure 16: Typical Rock Filled Crib

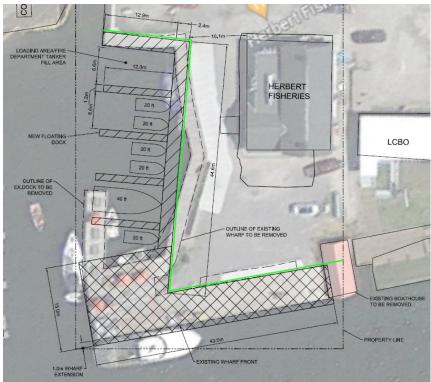
Figure 22: Construction Overview *note green line shows extent of new steel sheet pile sea wall

A new floating dock (2.4m wide) will be installed along the north, and east portions of the new sheet pile sea wall and will be attached to the sea wall with a typical roller slipper assembly. Four (4) new floating docks will be installed along the west edge of the east section of the new steel sheet pile sea wall. Each dock will be about 1.2m wide by about 12m long. These floating docks will be attached to the 2.4m wide floating dock noted above.

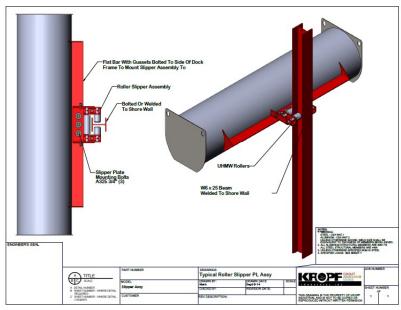
Figure 24: Typical Floating Dock Connection to Steel Sheet Pile Wall Detail

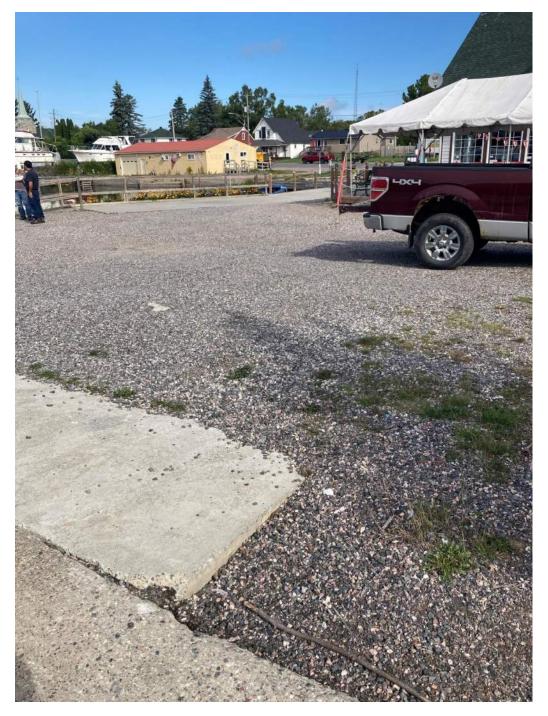
Photograph No. 5 Thin layer of gravel fill used to grade the Site.

Fill materials (gravel) were noted on Site during the Site visit. The fill materials were used to grade out the property and are of unknown quality; however, no obvious contamination is expected in the fill material.

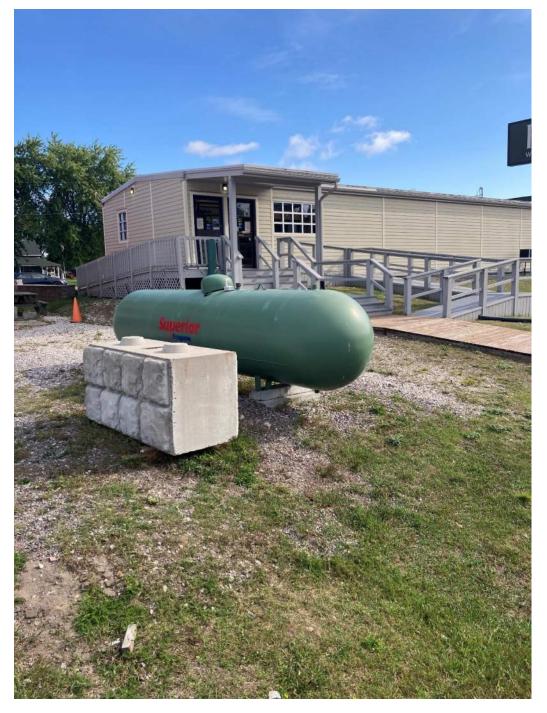
Photograph No. 6 Propane storage tank in east-central area of the Site.

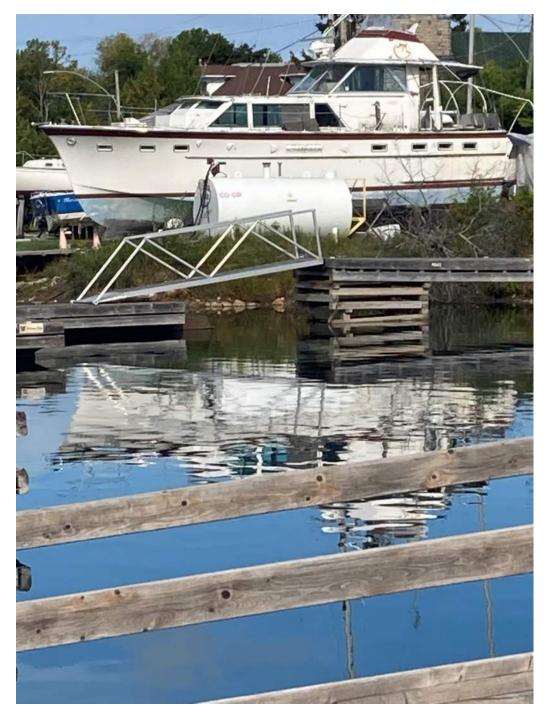
Photograph No. 10 AST on property west adjacent to Site.

West – a boat marina containing boat storage, docks and an AST. The AST appeared to be in good condition.

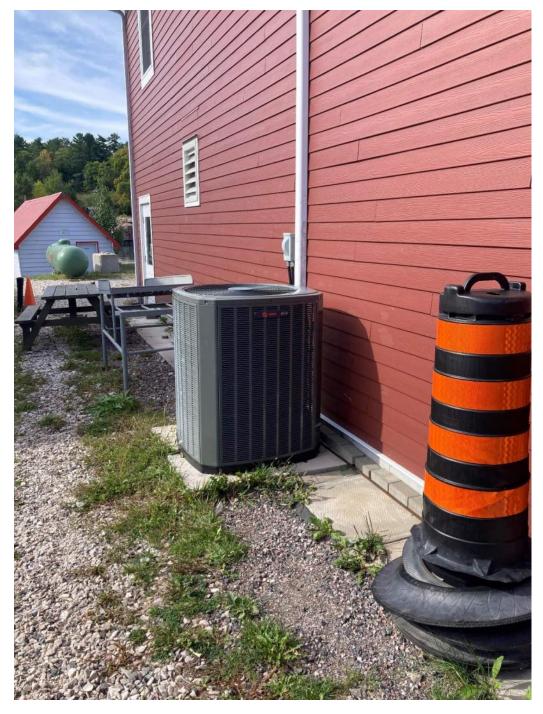
Photograph No. 11 Air conditioning unit on east wall of central building.

A single unit was noted on the east side of the central building, which appeared in good condition.

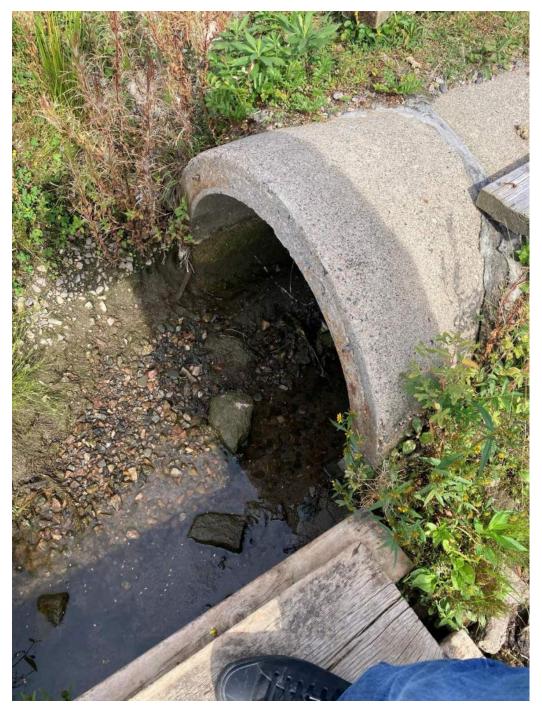
Photograph No. 17 Storm sewer discharge to Killarney Channel in northwest area of the Site.

No significant ditches or Site drainage structures were noted at the Site. A single stormwater pipe enters along the northwest boundary of the Site and empties into Killarney Channel.

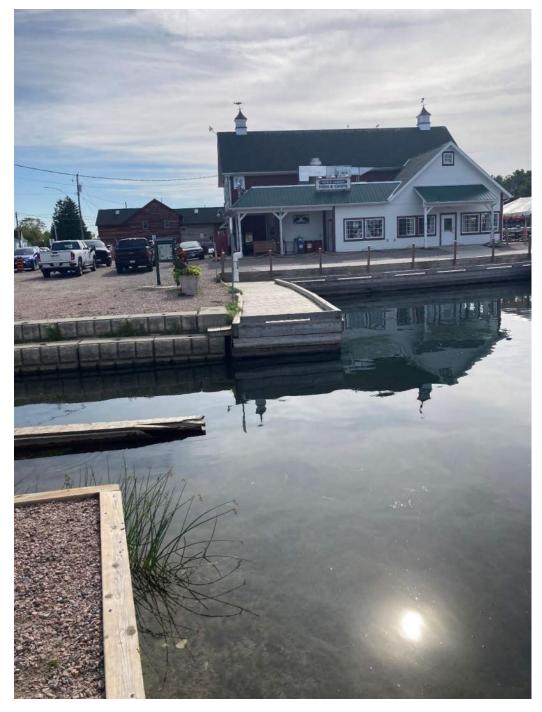
Photograph No. 21 Natural ground (left of retaining wall) and engineered ground (right of retaining wall) boundary.

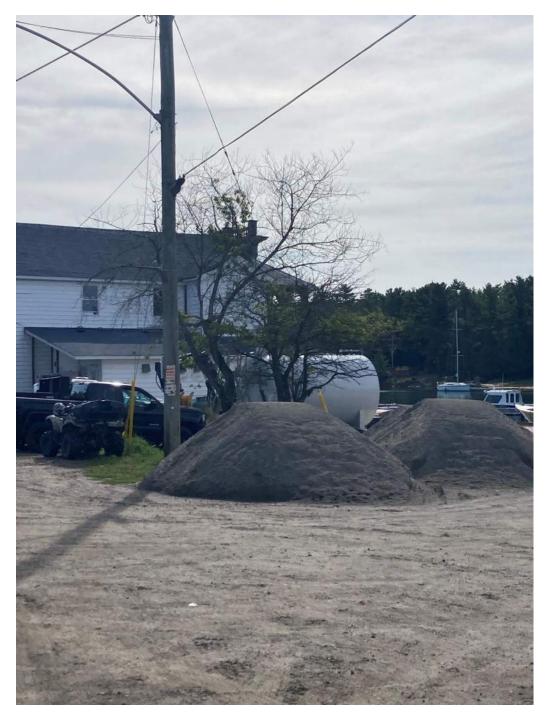
Photograph No. 22 AST located adjacent to generally store, east of the Site.

**East** – LCBO, beyond which is a commercial structure. A general store and AST are located beyond the aforementioned commercial structure. The AST appears in good condition.

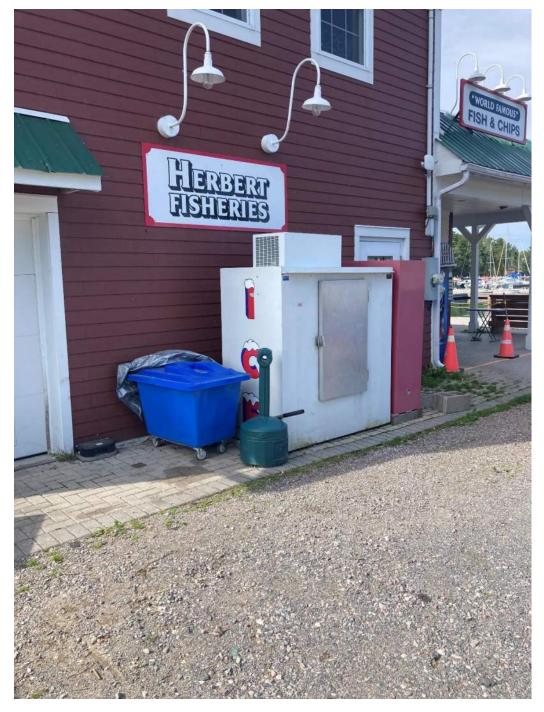
Photograph No. 23 Retail freezer unit on north side of central building (good condition).

A single, privately owned freezer unit was noted in the central building. Due to its age and apparent good condition, it is assumed there is a low probability for extensive ODSs on the Site.
